Subject: Department of Natural Resources Washington Geological Survey,
School Seismic Safety Assessment Project, Contract No. AE 410 -
Seismic Evaluation for **Mansfield School District**

School Buildings Evaluated in the Mansfield School District

1. Mansfield Elem and High School, Main Building

Mansfield, Mansfield Elem and High School, Main Building

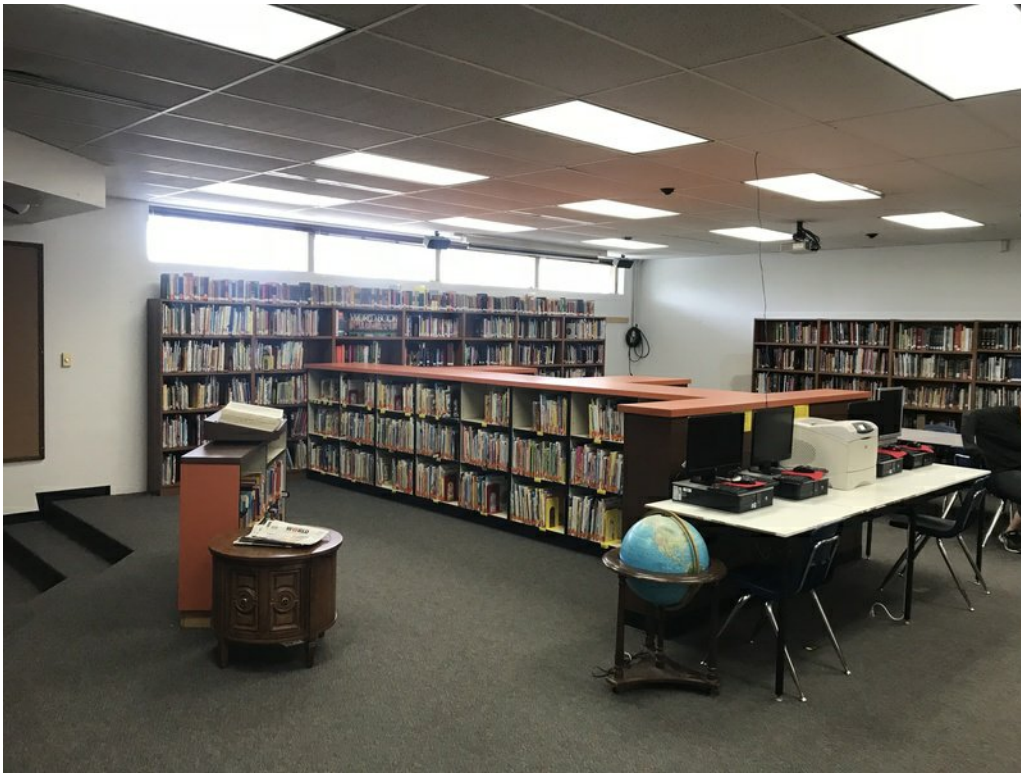
Figure 1-3. Library. The tall shelves were positively connected to the walls.

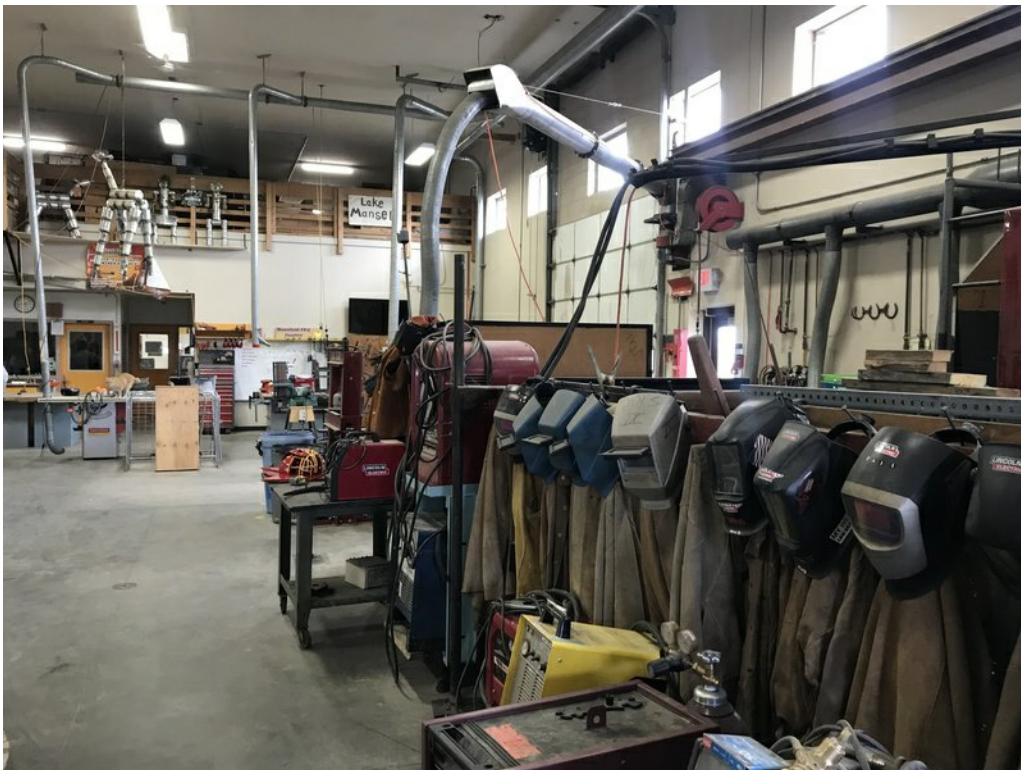
Unknown Item	Description
Load Path	No existing drawings and inadequate access to verify. Based on observation and age of building, it is assumed to be compliant.
Mezzanines	Connection of partial mezzanine in shop area not visible.
Vertical Irregularities	No existing drawings and inadequate access to verify, but likely compliant.
Torsion	No existing drawings available. Unable to make proper assumptions to determine compliance due to the geometry of the building.
Shear Stress Check	No existing drawings available, but likely compliant based on amount of wall.
Reinforcing Steel	No existing drawings available.
Wall Anchorage	No existing drawings and inadequate access to verify.
Wood Ledgers	No existing drawings and inadequate access to verify.
Transfer to Shear Walls	No existing drawings and inadequate access to verify.
Foundation Dowels	No existing drawings and inadequate access to verify; likely compliant.

Figure 1-4. Ag shop; woodworking tools are in the background, welding stalls on the right side of the picture. A storage mezzanine can be seen along one wall.

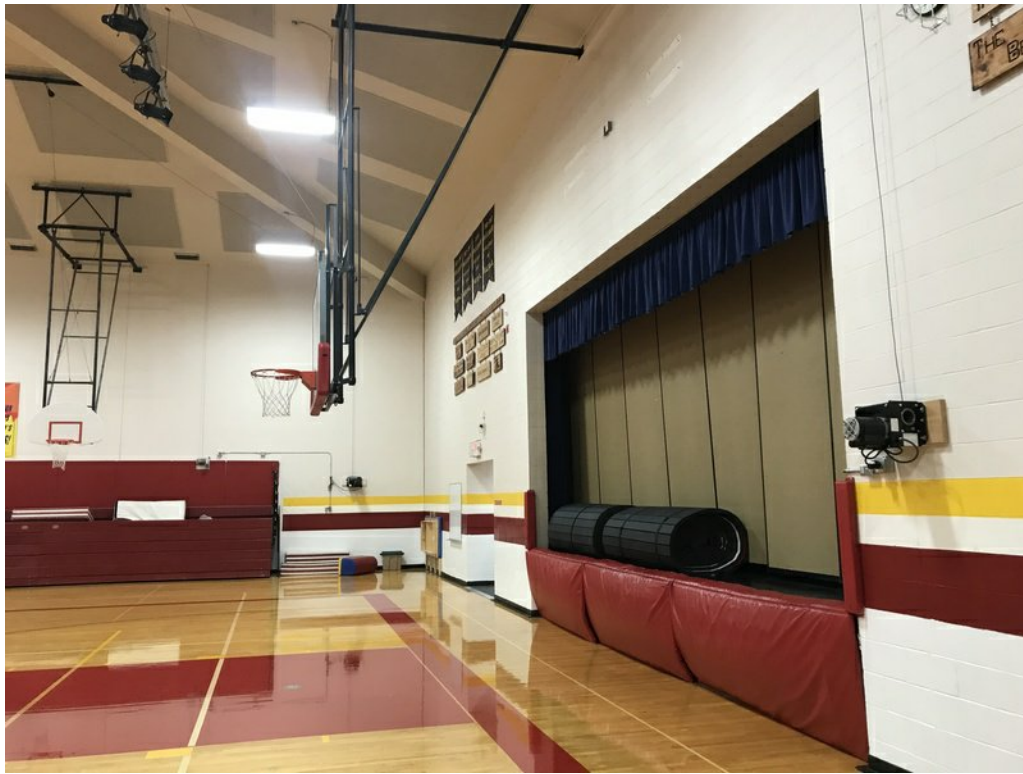
Figure 1-5. Gymnasium wall with performing stage. Some cracking was observed under the beam pockets at intersection of the walls.

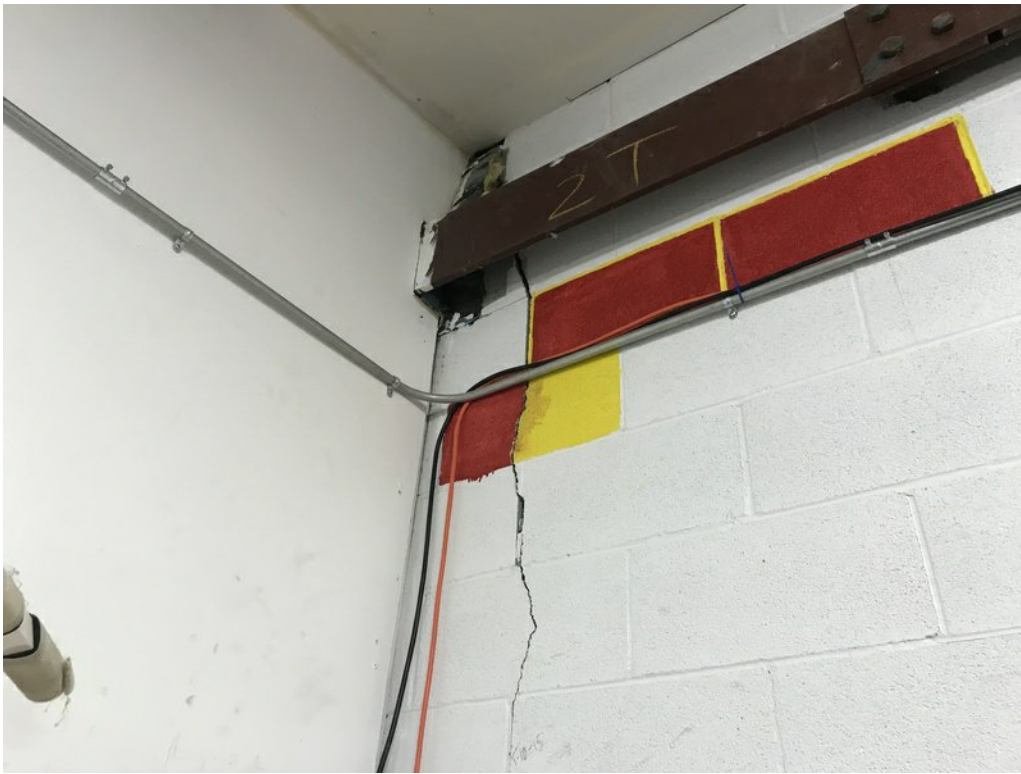
Figure 1-7. Large crack in the weight room.

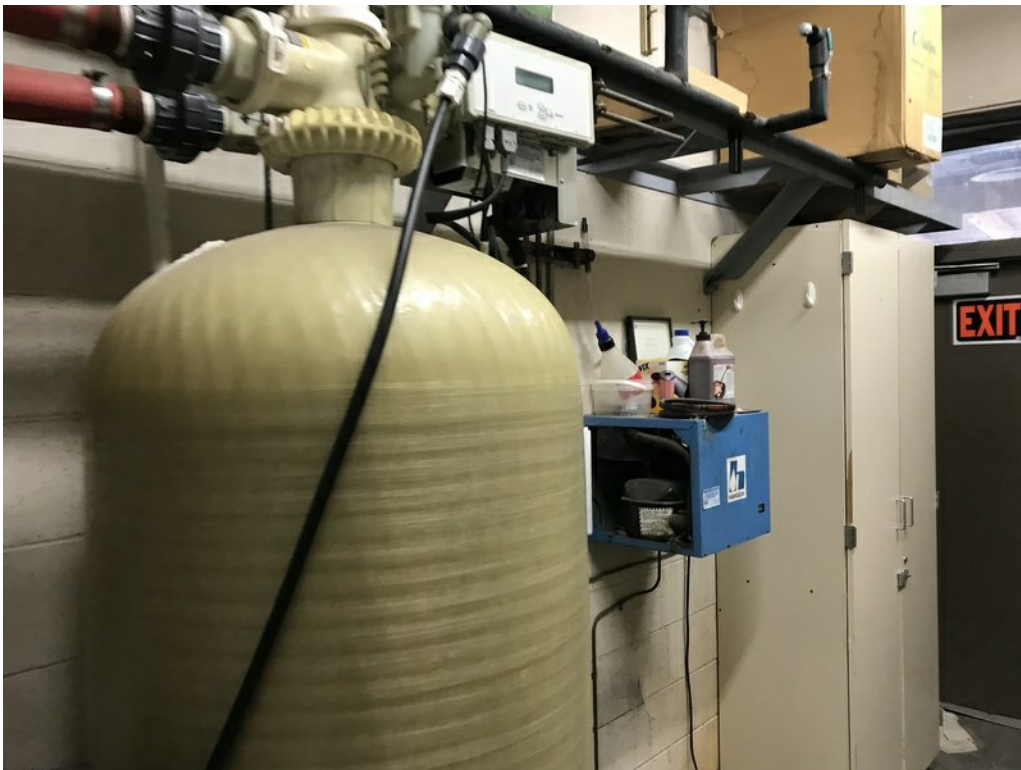
Deficiency	Description
CF-3 Fall-Prone Contents. HR-not required; LS-H; PR-H.	Large tank observed with no lateral strapping.

Figure 1-8. Unbraced tank in mechanical room.
